COVERING ALL THE BASES

Coating Work at the Cowans Ford Hydroelectric Station

BY TODD CEOL, SUPERIOR INDUSTRIAL MAINTENANCE CO., LLC

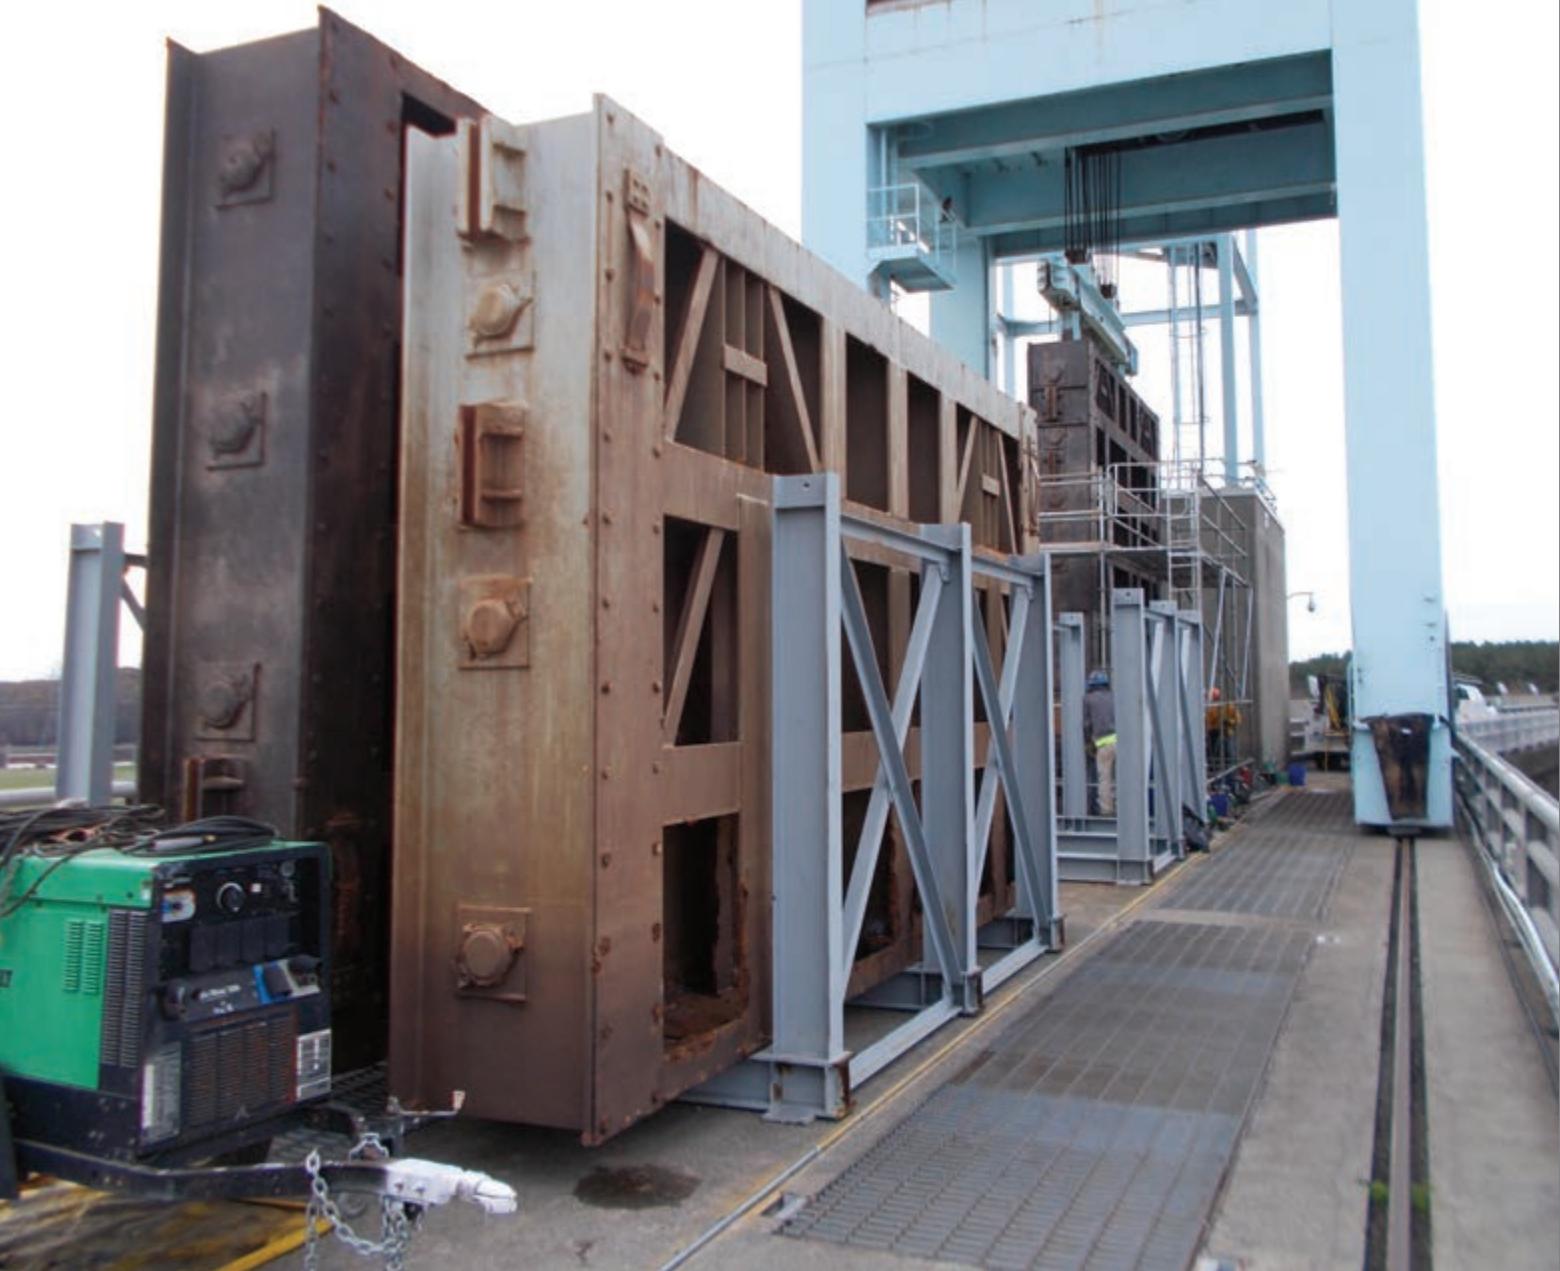
FIG. 2: Intake pieces were disassembled before being transported by crane to an onsite building for repairs, blasting and coating.

and intake slots (*Fig. 2*). It is important to keep in mind that each tailrace gate consisted of one piece, but each intake gate had to be disassembled to form three separate pieces. The stop log pieces were also individual pieces, with two sets of stop logs consisting of eight total pieces.

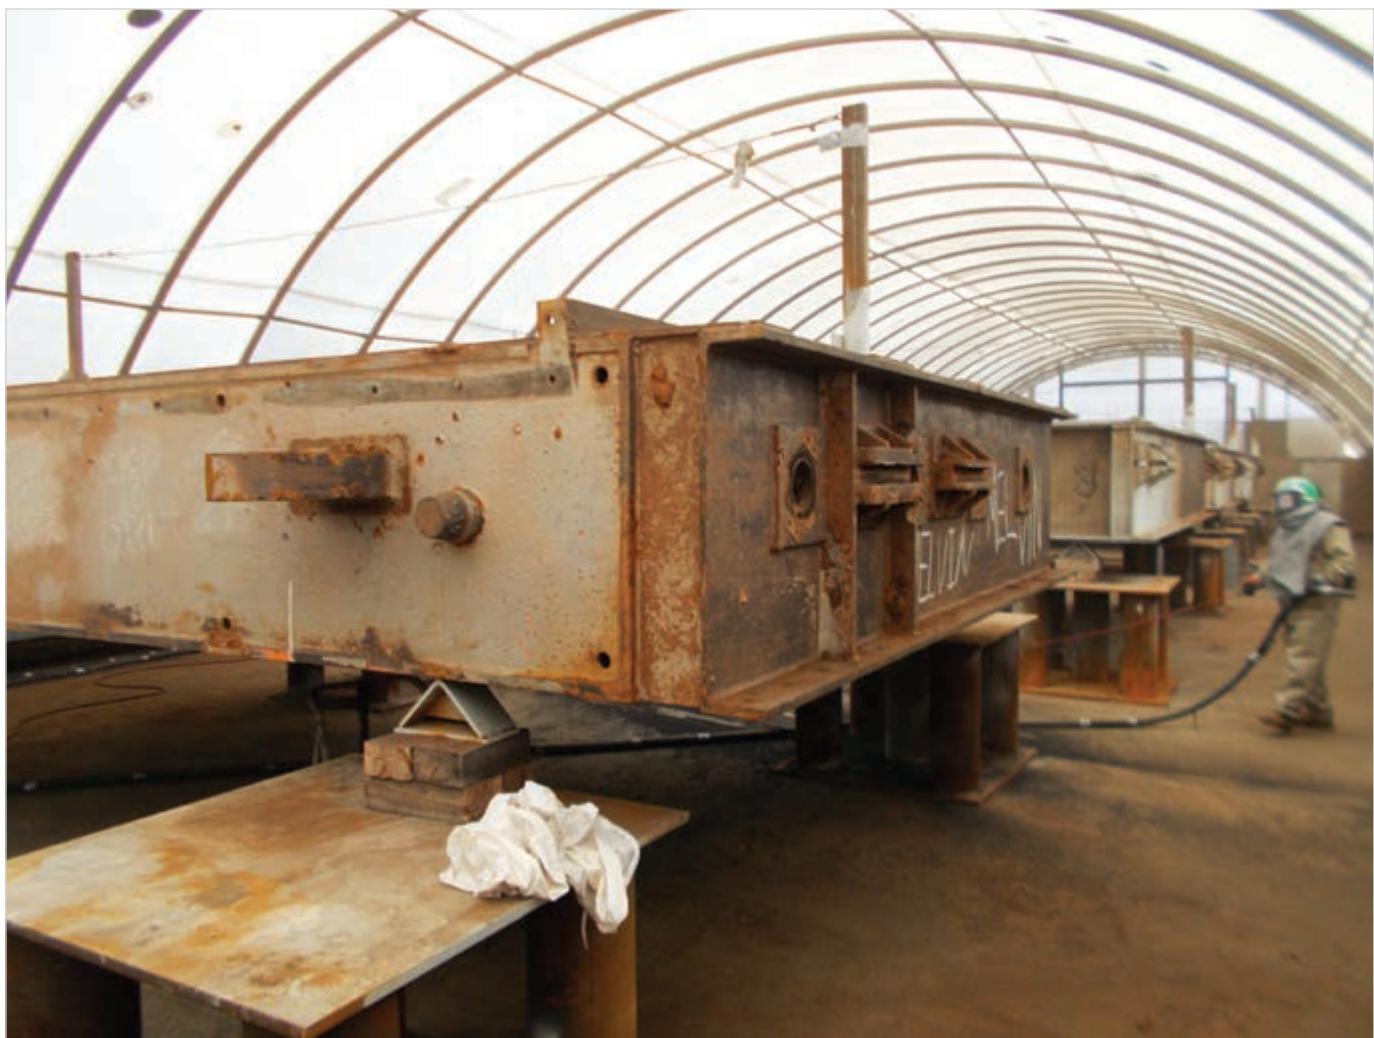
FIG. 3: Crane picks were coordinated with a crane subcontractor to get the intake pieces to the onsite building.

The contractor teamed up with a crane subcontractor for all of the project's crane and shipping needs, including transport of these items to the onsite building (*Fig. 3*) and the contractor's blasting and coating shop. Use of the crane proved to be one of the biggest challenges on the project, as each crane pick had to be scheduled in advance and include a facility owner-approved crane safety plan. It took

multiple trailers to get the crane to the site, which created congestion onsite during transport. Weather conditions were continuously monitored, and high wind advisories caused the rescheduling of several crane picks throughout the project, as well. However, due to pre-planning and communication between the contractor, the crane subcontractor and the facility owner, these challenges were overcome and the process went smoothly and without incident from the first pick to the last.

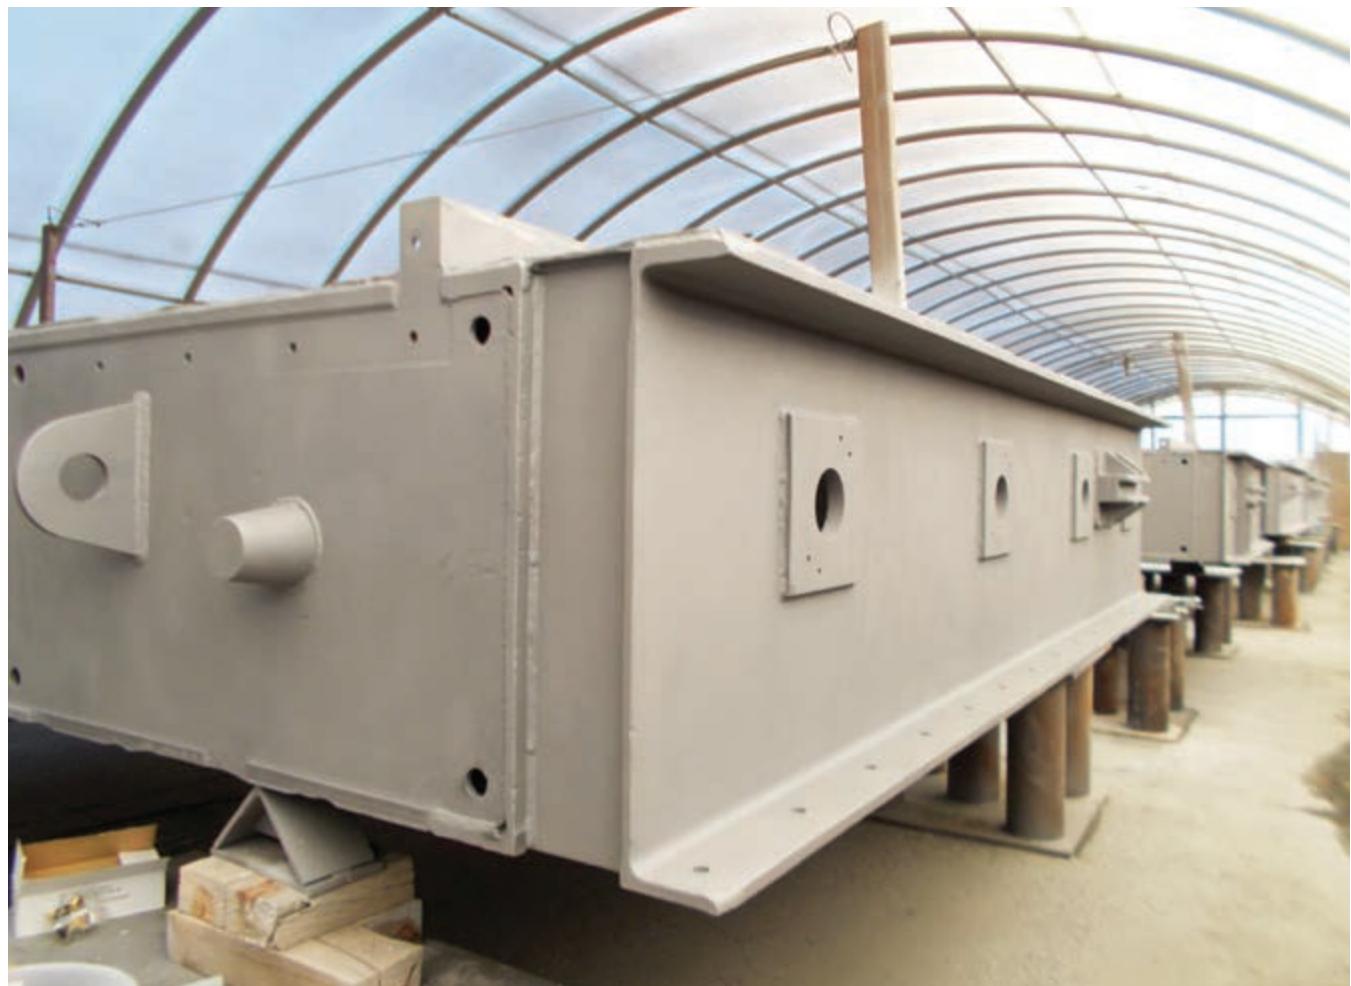
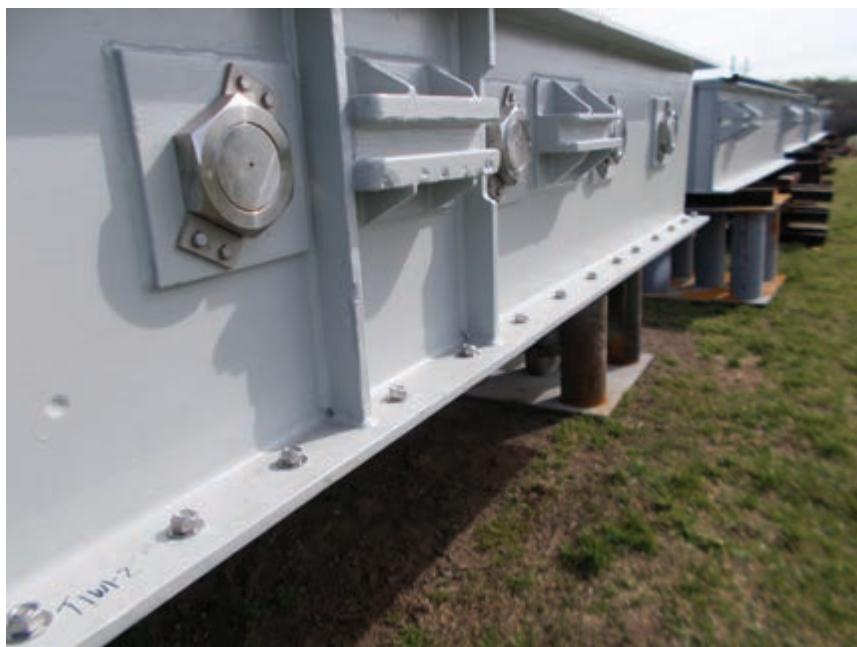
FIG. 4: Intake and tailrace pieces received two stripe coats and three full coats of a polyamide epoxy coating.

pieces were then inspected by the facility owner to identify any needed repairs; after these were performed, the items were re-blasted and coated with two stripe coats and three full coats of polyamide epoxy at 4–6 mils' DFT per coat (*Fig. 4*).

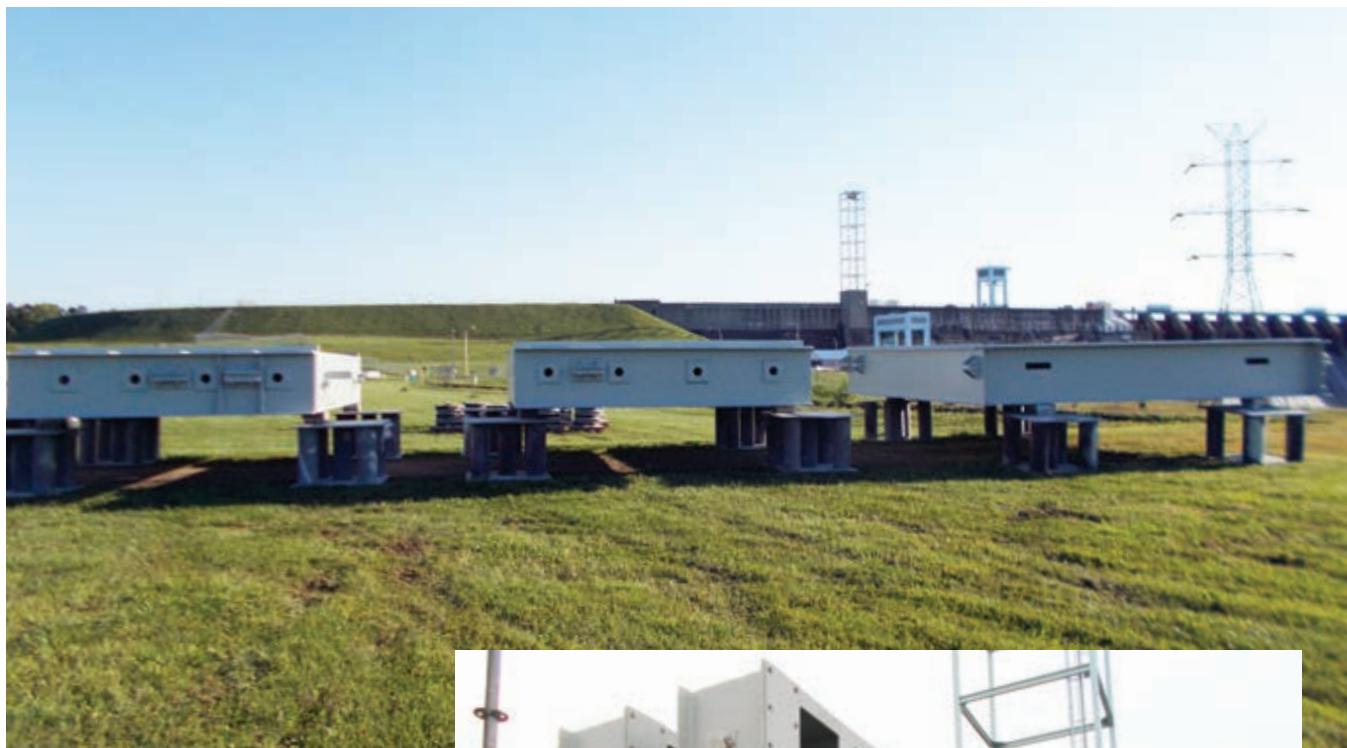
FIG. 5: Finished intake pieces were moved to a laydown area before being placed back in the water.

areas per the facility owner's specifications. After final inspection, the items were set in a laydown area before being reinstalled back in the water (*Fig. 5*), and additional pieces were removed to bring back to the onsite building.

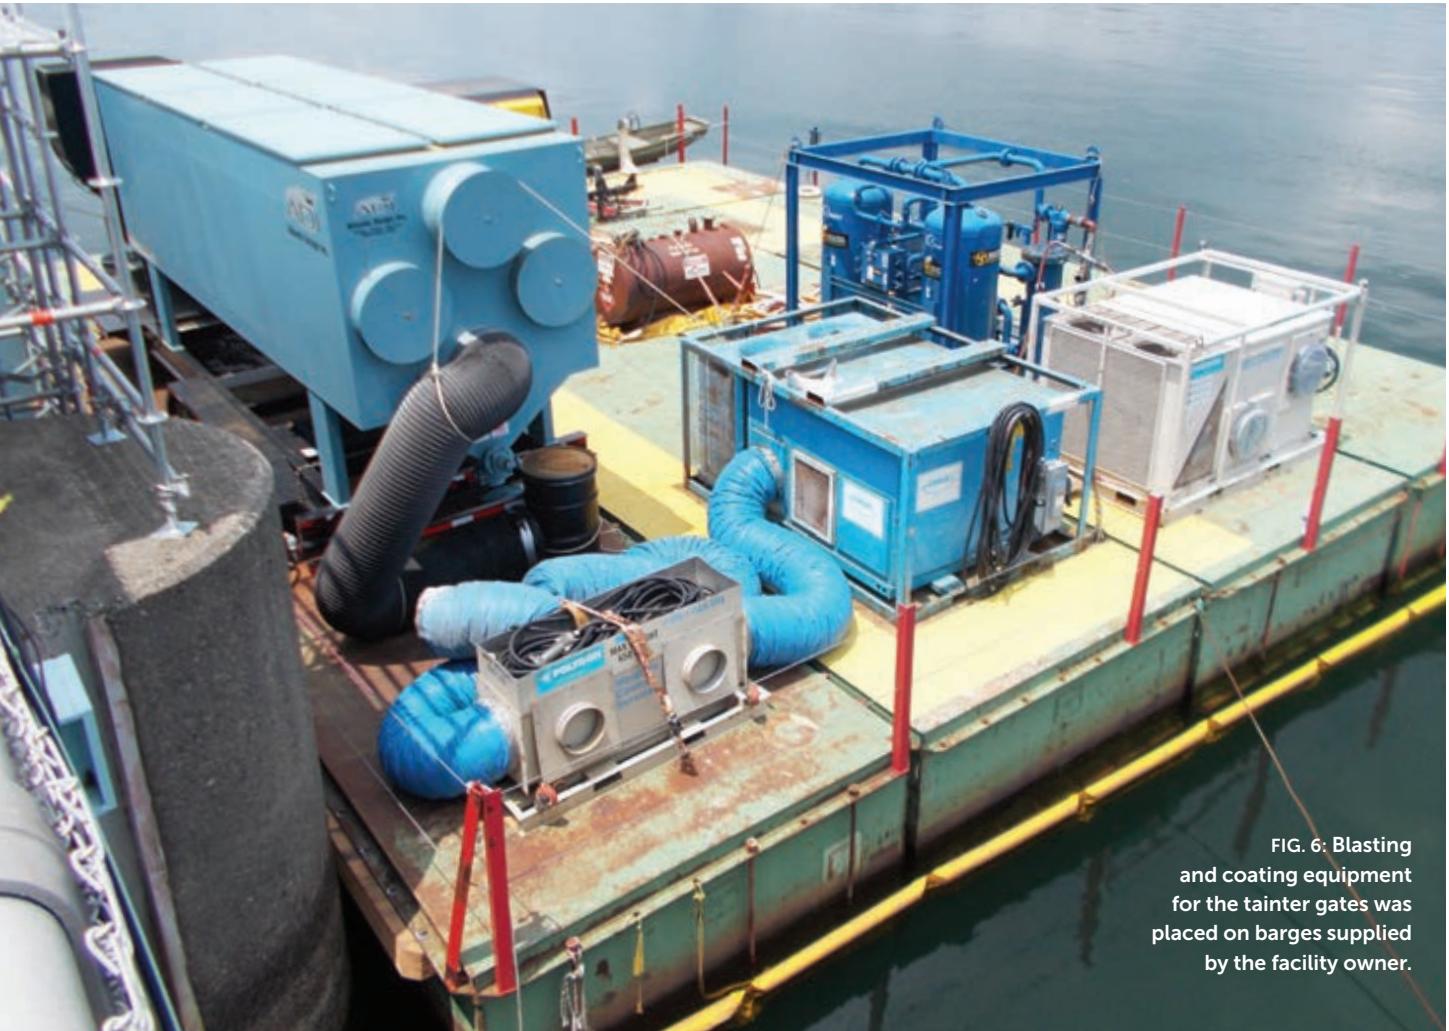
FIG. 6: Blasting and coating equipment for the tainter gates was placed on barges supplied by the facility owner.

to complete the work on the tainter gates had to be set on barges, which were supplied by the facility owner (*Fig. 6, next page*).

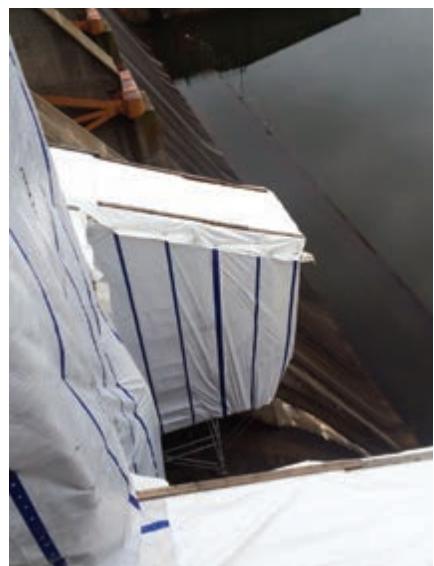
FIG. 7: Containment and scaffolding structures were constructed around tainter gates during the project.

Environmental hazards were a significant part of the complexity of this job, based on the existing lead paint involved and the work taking place so close to the water, requiring scaffolding and containment by a subcontractor (*Fig. 7, next page*). The contractor blasted and coated each tainter gate to the same specifications,

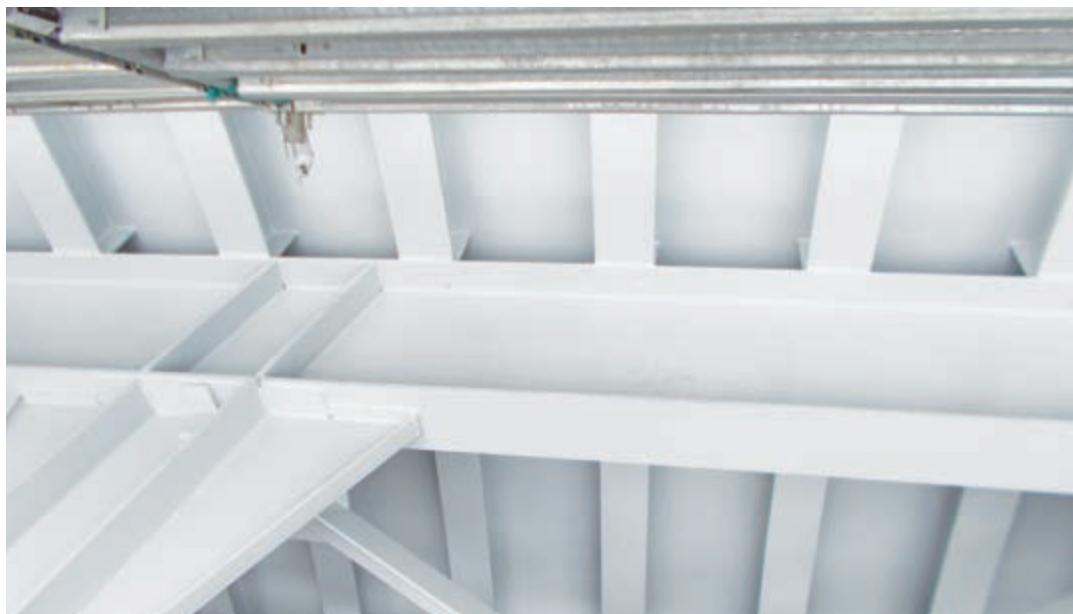
FIG. 8: The downstream sides of the tainter gates received an additional coating of epoxy and an acrylic polyurethane finish coat.

though the downstream side of each gate received one coat of an epoxy at 4–6 mils DFT and one coat of an acrylic polyurethane finish coat applied at 3–5 mils DFT (*Fig. 8*).
